The 2<sup>nd</sup> International Conference on Rehabilitation and Maintenance in Civil Engineering

## Lesson Learned from 27<sup>th</sup> May 2006 Yogyakarta Earthquake - Case of Building with Long Span of Roof Structure

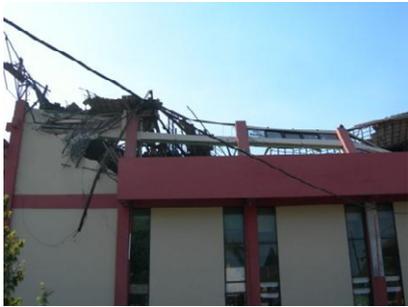
Some of collapse of engineered buildings in Yogyakarta earthquake had long span roof structures. Figures 2, 3, and 4 show some collapse of engineered buildings which had long span of roof structures.

Figure 2. Among Rogo sport building.

The collapse of engineered buildings which had long span roof structures probably due to the collapse of roof structure itself or the stiffness of the upper column is not sufficient to support the roof structure when subjected to the earthquake loading (Raharjo et al. 2007).

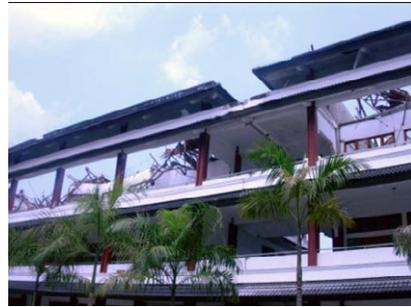
Figure 3. UAD Janturan building.

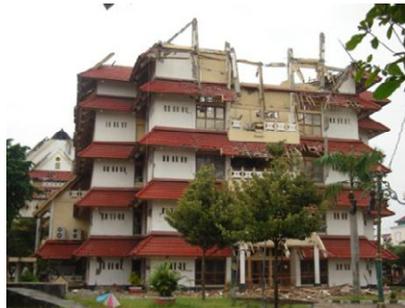
Figure 4. STIE Kerjasama building.

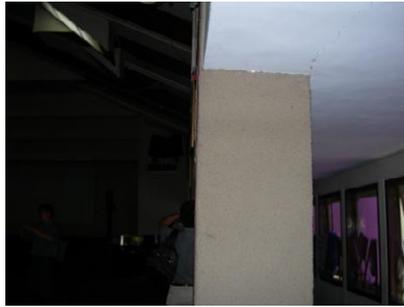
After the earthquake, some columns of the Auditorium which support the roof structures were cracks and declined (see Figure 6).

Figure 6. Columns of Auditorium were declined

Wibowo et al. (2007) stated that the failure columns in the Auditorium due to the capacity columns were not adequate to resist the combine loading including the earthquake loading. Wibowo et al. (2007) proposed two items for repairing the problem. First improving the stiffness of roof structure by adding truss elements into the original roof structure using steel shape of U 75x40x5x7 (see Figure 7).

Second for repairing the declined columns, they proposed to repair the columns by using jacketing methods with steel structure (see Figure 8).

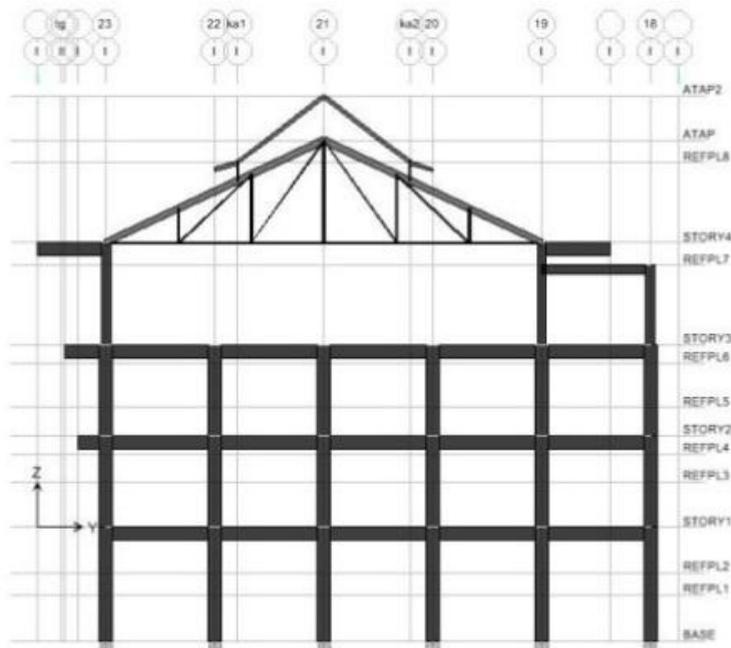
Figure 7. Modified roof structure of Auditorium (Wibowo et al. 2007)

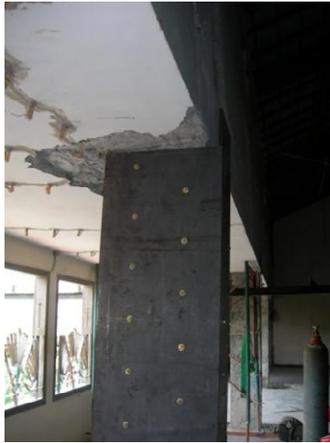
Figure 8. Jacketing method for declined column (Wibowo et al. 2007)
