The 2<sup>nd</sup> International Conference on Rehabilitation and Maintenance in Civil Engineering

## Lesson Learned from 27<sup>th</sup> May 2006 Yogyakarta Earthquake - Case of Building with Long Span of Roof Structure

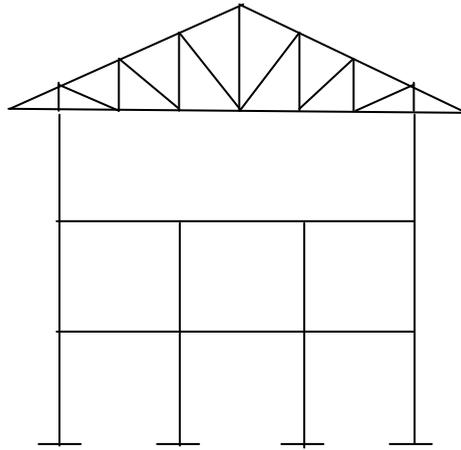
Figure 1. Long span roof structure.

The failure of structural elements such as beams, columns, floor and roof structures can be categorized as structural failure. Generally, the meeting room or hall such as auditorium was designed on the upper floor below the roof structure. This design made the roof structure has a long span as shown in the Figure 1.

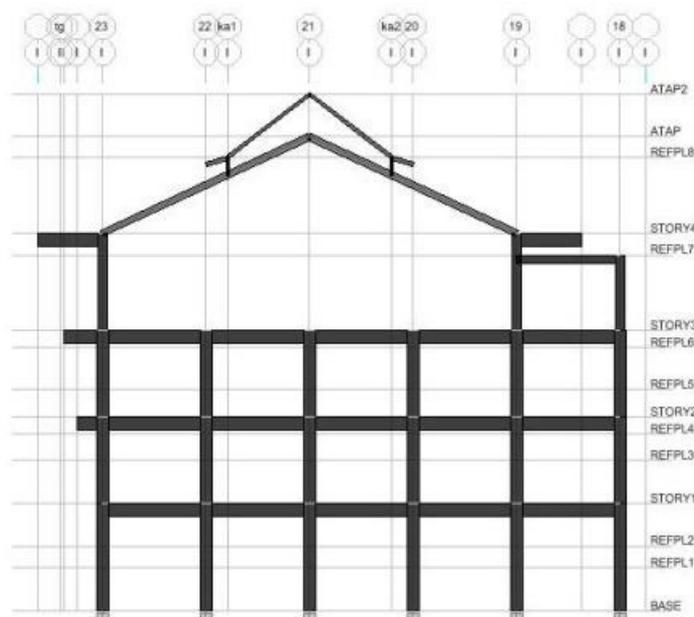
Figure 5. Originally roof structure of Auditorium.

The area of Auditorium is 898.56 m<sup>2</sup> or (46.8 meter x 19.2 meter). There are no column in the middle of space of Auditorium, so the column only at the edge of the Auditorium. Therefore, the span of the roof structure was 19.2 meter. The original roof structure of the Auditorium before earthquake is shown in the Figure 5. The roof structure was made of steel structure and used Wide Flange steel shape (IWF300x150x6.5x9).

After the earthquake, some columns of the Auditorium which support the roof structures were cracks and declined (see Figure 6).

Wibowo et al. (2007) stated that the failure columns in the Auditorium due to the capacity columns were not adequate to resist the combine loading including the earthquake loading. Wibowo et al. (2007) proposed two items for repairing the problem. First improving the stiffness of roof structure by adding truss elements into the original roof structure using steel shape of U 75x40x5x7 (see Figure 7).
